**WATER QUALITY MONITORING REPORT
COLUMBIA COUNTY SOIL AND WATER CONSERVATION DISTRICT
WATER QUALITY TRENDS MONITORING PROGRAM
2017-2020**

Columbia County SWCD

Lower Columbia Estuary Partnership

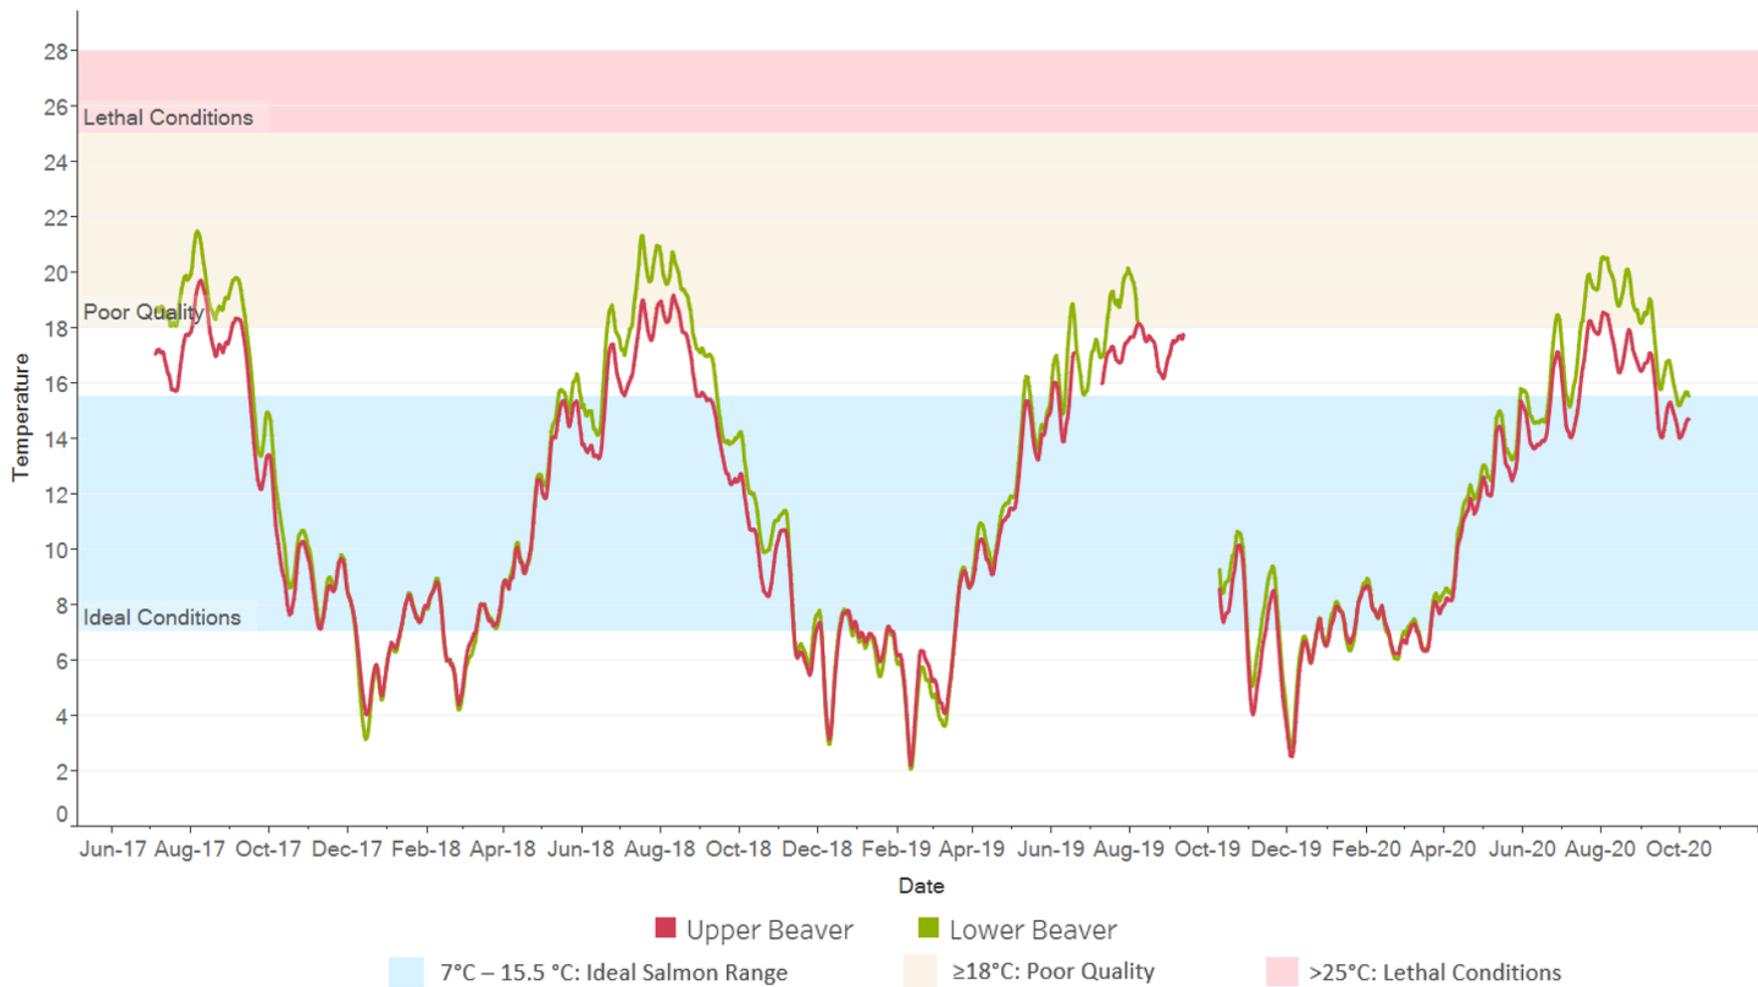
Figure 20: Beaver Creek Watershed 7-day average maximum temperatures (7dMAM) from June 2017 to October 2020 overlaid on salmonid temperature threshold ranges. See Table 3 for temperature threshold details.

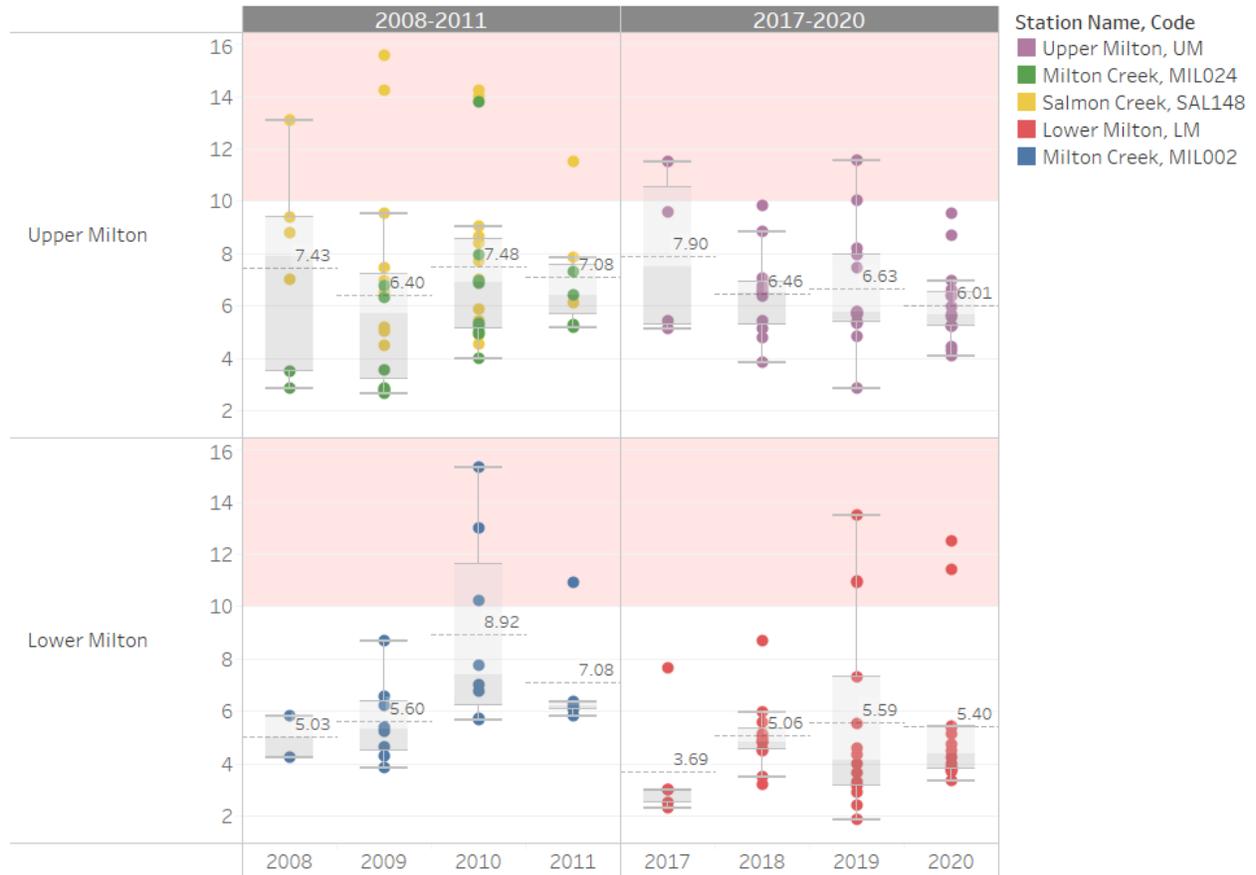
Figure 32: Turbidity (NTU) grab sampling results (boxplots) for Milton Creek Watershed broken down across years sampled. Sampling locations are highlighted within each boxplot. 10 NTU threshold highlighted in pink. Overall mean for each year highlighted. A summary of these data can be found in Appendix B.

Figure 32: Turbidity (NTU) grab sampling results (boxplots) for Milton Creek Watershed broken down across years sampled. Sampling locations are highlighted within each boxplot. 10 NTU threshold

highlighted in pink. Overall mean for each year highlighted. A summary of these data can be found in Appendix B. 63

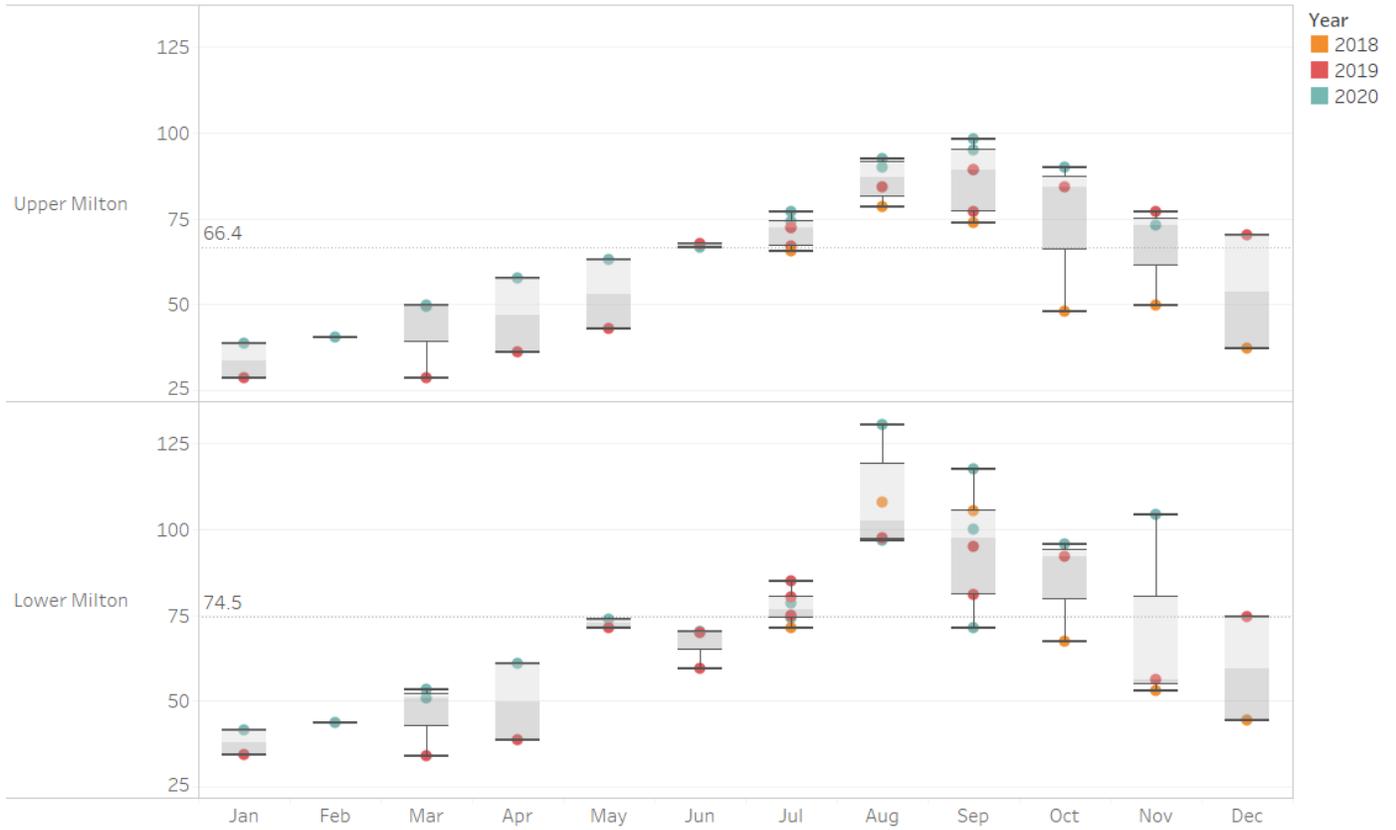
Figure 35: Conductivity levels ($\mu\text{s}/\text{cm}$) 2018-2020 Grab Samples results (boxplots) for Milton Creek watershed broken down across months sampled and watershed sampling location. Sampling years ranging from 2018 to 2020 are highlighted within each boxplot. The overall mean for the study period is highlighted in each graph.

Figure 35: Conductivity levels ($\mu\text{s}/\text{cm}$) 2018-2020 Grab Samples results (boxplots) for Milton Creek watershed broken down across months sampled and watershed sampling location. Sampling years ranging from 2018 to 2020 are highlighted within each boxplot. The overall mean for the study period is highlighted in each graph. 69

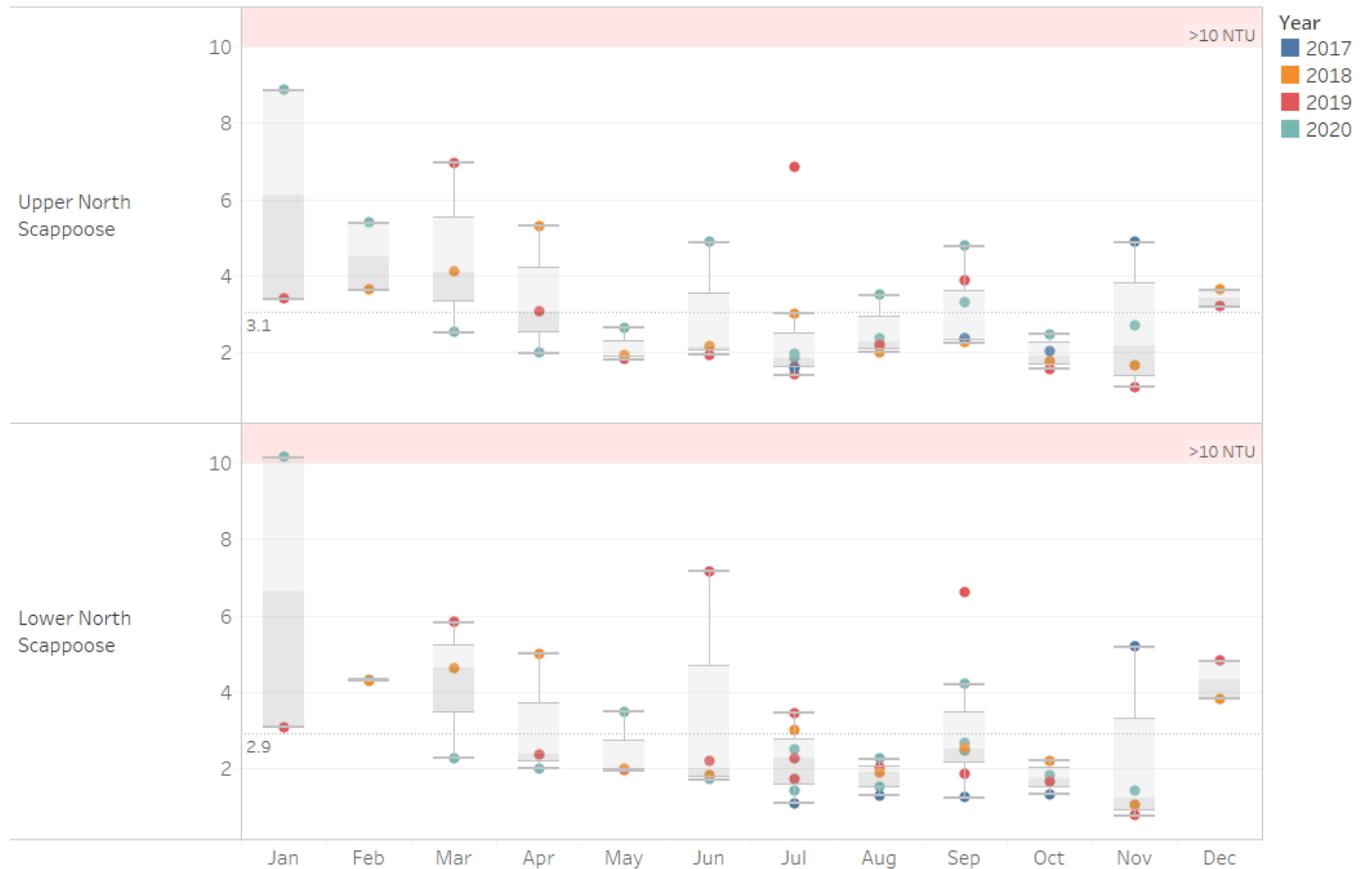
Figure 44. Turbidity (NTU) grab sampling results (boxplots) for North Scappoose Creek Watershed broken down across sampling locations and months sampled. Sampling years ranging from 2017 to 2020 are highlighted within each boxplot. 10 NTU threshold highlighted in pink. The overall mean for the study period highlighted in each graph. A summary of these data can be found in Appendix B.

Figure 44. Turbidity (NTU) grab sampling results (boxplots) for North Scappoose Creek Watershed broken down across sampling locations and months sampled. Sampling years ranging from 2017 to 2020 are highlighted within each boxplot. 10 NTU threshold highlighted in pink. The overall mean for the study period highlighted in each graph. A summary of these data can be found in Appendix B. 80

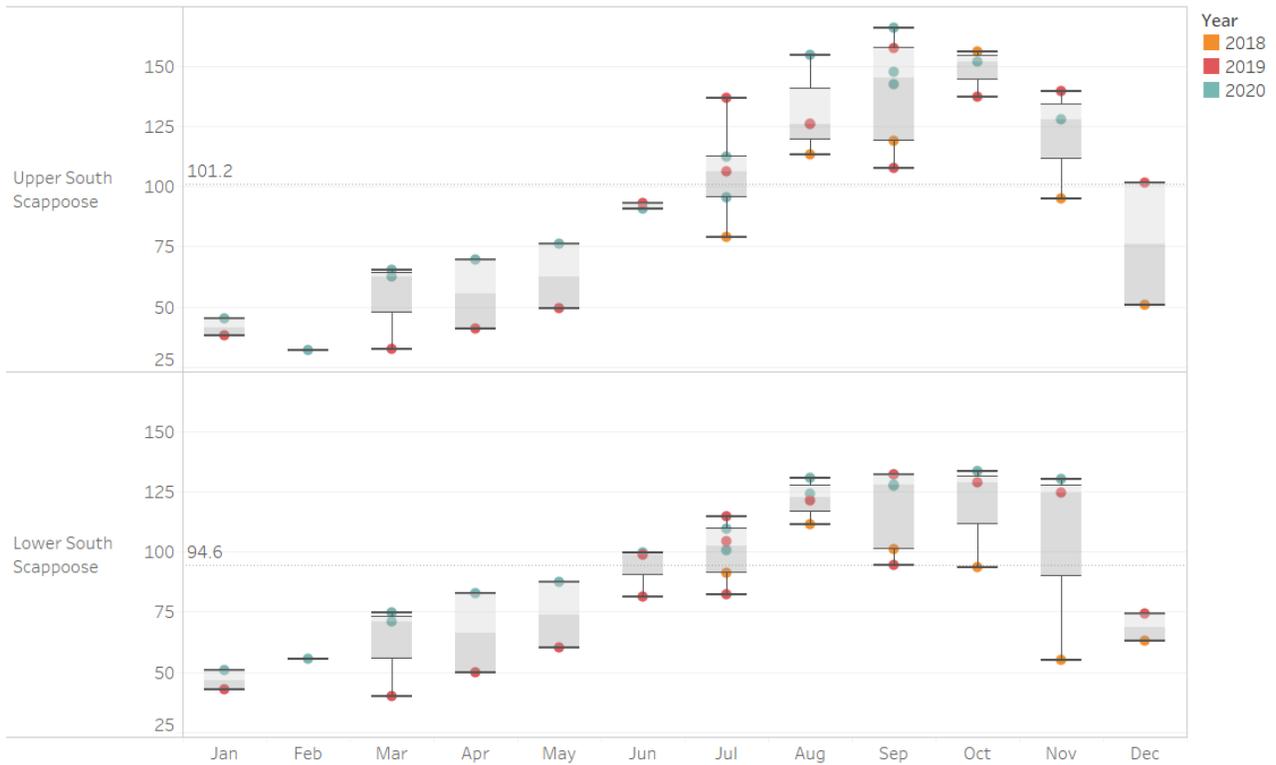
Figure 60: Conductivity levels ($\mu\text{s}/\text{cm}$) 2018-2020 Grab Samples results (boxplots) for South Scappoose Creek watershed broken down across months sampled and watershed sampling location. Sampling years ranging from 2018 to 2020 are highlighted within each boxplot. The overall mean for the study period highlighted in each graph.

South Scappoose Creek Watershed Monthly Conductivity Levels ($\mu\text{s}/\text{cm}$)
2018-2020 Grab Samples

Conductivity levels varied seasonally across monitoring locations within the South Scappoose Creek watershed (Figure 60, Table 38). At both locations, annual increases in water conductivity were observed between April to September and declined from October to February (Figure 60, Table 38). Between 2018-2020, Upper South Scappoose Creek exhibited lower overall mean conductivity levels ranging from 59-71 $\mu\text{s}/\text{cm}$ compared to 70-79 $\mu\text{s}/\text{cm}$ observed at the Lower South Scappoose Creek monitoring location (Figure 60, Table 38). These data provide baseline conductivity levels that can be used to identify new and emerging water quality issues or improvements over time. When comparing the 2018-2020 data to the 2008-2011 data, no significant shift in conductivity was observed (Figure 61). Pollution from runoff or increased turbidity levels from erosion can result in higher conductivity levels; however, there is no EPA or ODEQ threshold for conductivity in the region.

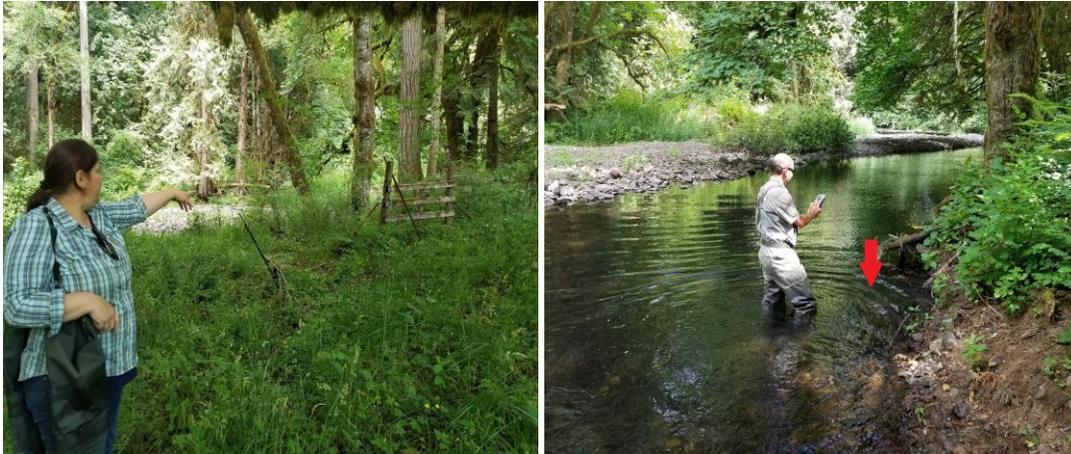
Location Image: River access just beyond old fence gate, near bank root overhang

Clatskanie Watershed						
Site Code	Site Name	Description	GPS Coordinates	Logger Serial Number	Installed Date/Time	Installed Temp °C
LC	Lower Clatskanie	Data: Bacteria, Temp/WL, Turbidity	Lat: 46.080002 Long: -123.166841	20112654	8/17/2017 15:30	19.8
Site Code	Site Name	Description	GPS Coordinates	Logger Serial Number	Installed Date/Time	Installed Temp °C
MC	Middle Clatskanie	Data: Temp/WL, Turbidity Private property (must notify owner ahead of time) off of Swedetown road, walk through field behind the home, then cross through an old gate to access river. Data logger placed near an undercut bank with some overhanging roots	Lat: 46.045193 Long: -123.095813	20112657	6/28/2017 15:28	14.6

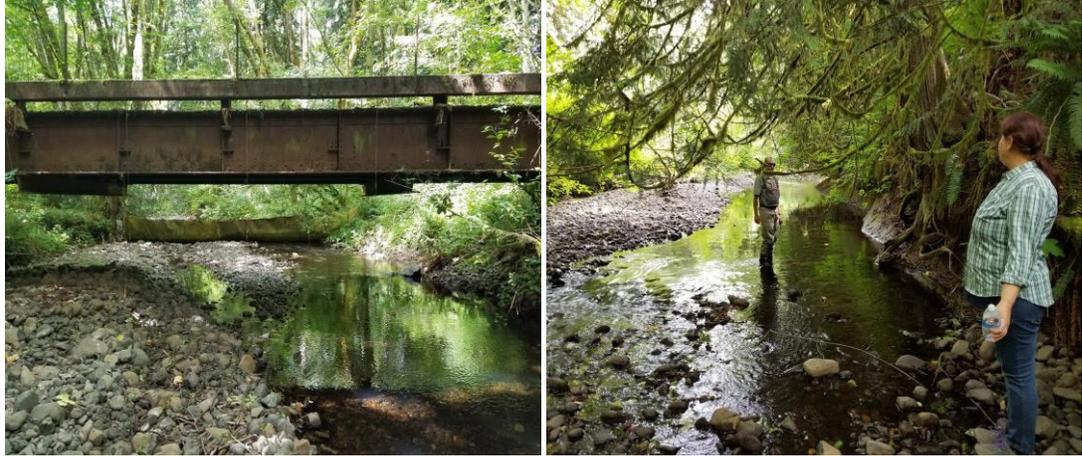
Location: Looking up stream at bridge, looking down stream towards data logger placement

Site Code	Site Name	Description	GPS Coordinates	Logger Serial Number	Installed Date/Time	Installed Temp °C
CAR	Carcus	Data: Temp/WL, Turbidity Stream accessed via private drive off Swedetown Rd, data logger placed a few meters upstream of the bridge (to be out of way of impending construction).	Lat: 46.038533 Long: -123.085543	20112662	6/28/2017 15:54	14.1

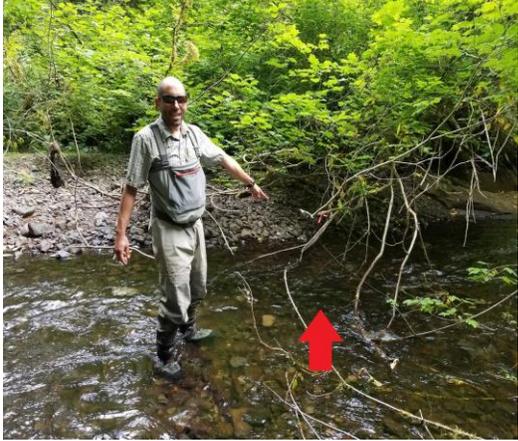
Matt standing near data logger placement location, under vine maple (flagged with pink tape)

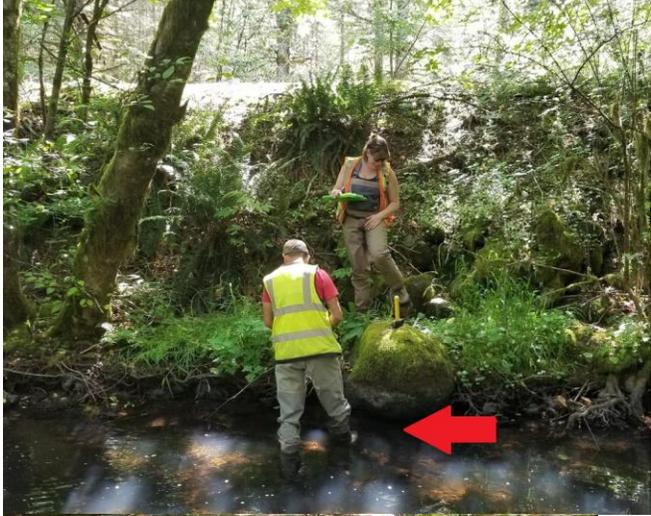
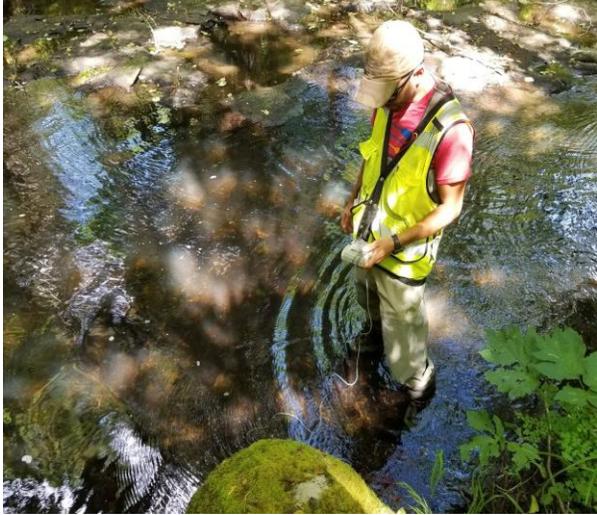
Location images: Data logger located near large rock along the river bank

Site Code	Site Name	Description	GPS Coordinates	Logger Serial Number	Installed Date/Time	Installed Temp °C
UC	Upper Clatskanie	Data: Temp/WL, Turbidity Just north of LC location on the other side of the Apiary road. Steep descent from road to stream. Data logger near large rock on road side of river bank.	Lat: 45.987717 Long: -123.040371	20112651	6/29/2017 11:43	12.8

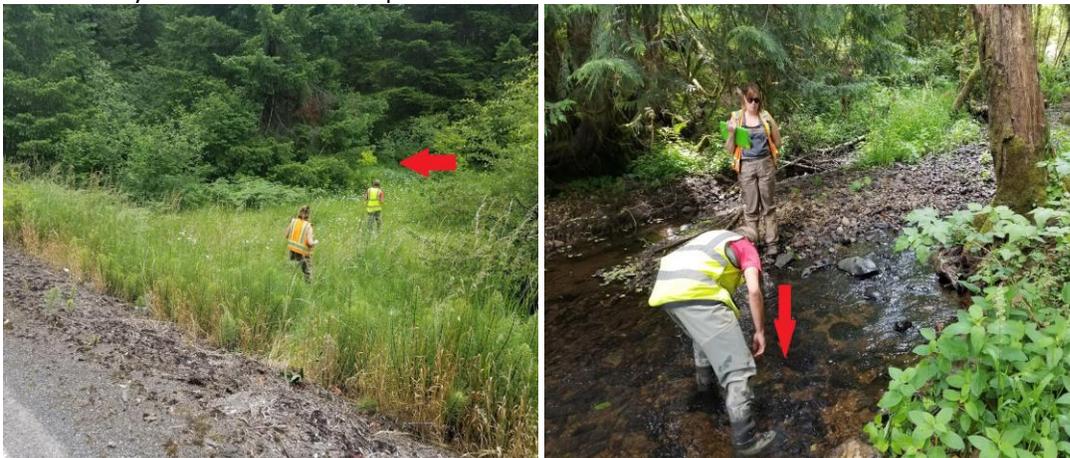
Grassy opening along right side of road side north of car pull out, data logger is located near flagging next to salmon berry shrub and cedar stump

Site Code	Site Name	Description	GPS Coordinates	Logger Serial Number	Installed Date/Time	Installed Temp °C
LitC	Little Clatskanie	Data: Temp/WL, Turbidity Park at pull out for logging road (on little Clat side of the road) along Apiary Market Rd and then access river via grassy opening along right side of road side north of car pull out, follow pink flagging to data logger location (downstream of large data logger housing)	Lat: 45.987598 Long: -123.038492	20112659	6/29/2017 11:23	12.7

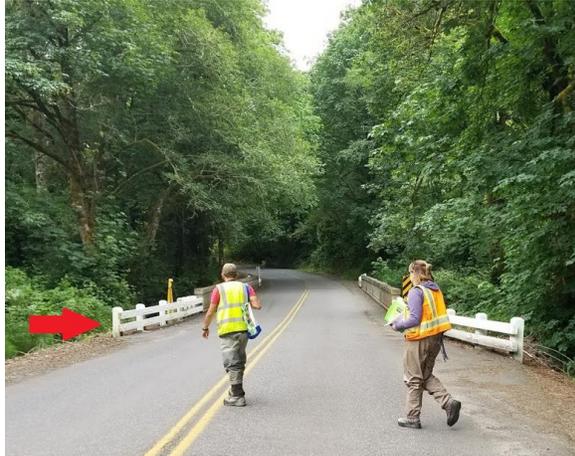
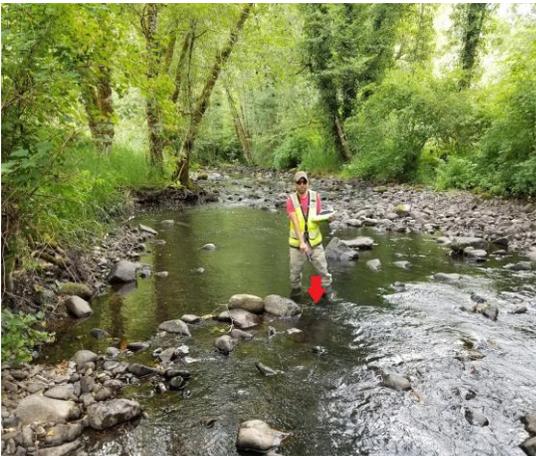
Beaver Creek Watershed						
Site Code	Site Name	Description	GPS Coordinates	Logger Serial Number	Installed Date/Time	Installed Temp °C
LB	Lower Beaver	Pull out before the bridge at Beaver Falls Rd, data logger placed at the end of a rock pile just upstream of the bridge (large current shrub on shore).	Lat: 46.108942	20112663	6/29/2017 10:09	14.3
			Long: -123.158919			
<p>Location images: Park on side of the road and access stream on upstream side of bridge, data logger placed at the end of a rock pile just upstream of the bridge (large current shrub on shore). Large rock near data logger placement marked with a black X.</p>

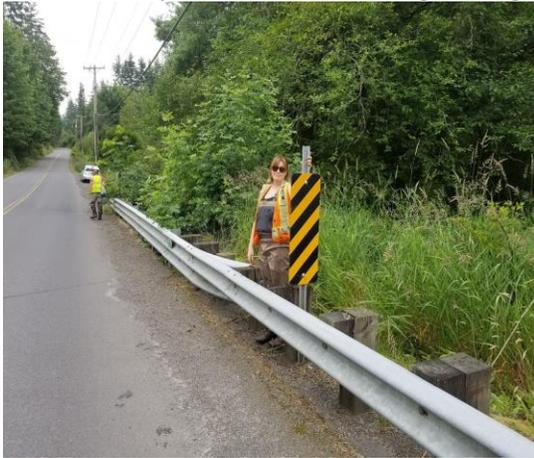
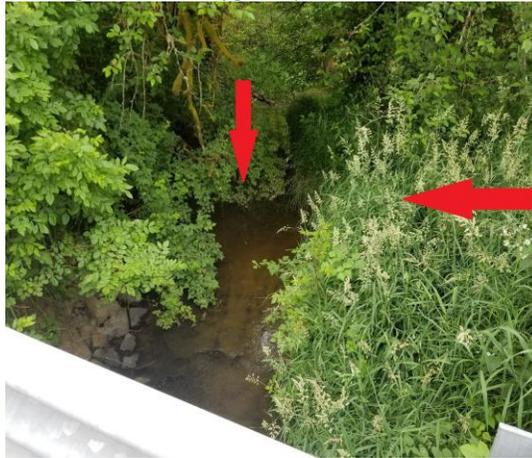
Location images: Park just past bridge on Fernhill Road (near 73723 Fern Hill Rd Rainier, Oregon), and walk down on the upstream side of the bridge through the large reed canarygrass patch.

Site Code	Site Name	Description	GPS Coordinates	Logger Serial Number	Installed Date/Time	Installed Temp °C
UB	Upper Beaver UB	Data: Temp/WL, Turbidity Park just past bridge on Fernhill Road (near 73723 Fern Hill Rd), and walk down on the upstream side of the bridge through the large reed canarygrass patch. Located upstream of bridge, under a large current shrub with pink flagging marking its location	Lat: 46.062373 Long: -122.965167	20112653	6/29/2017 10:44	14.0

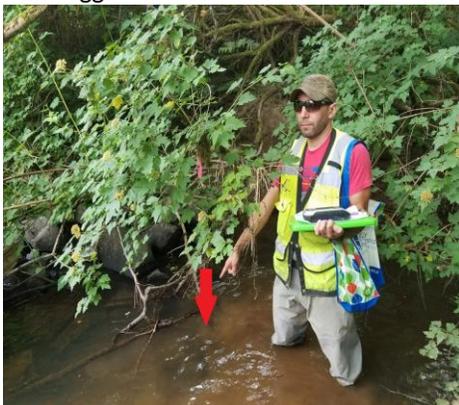
Data logger located under Currant shrub on far side of stream.

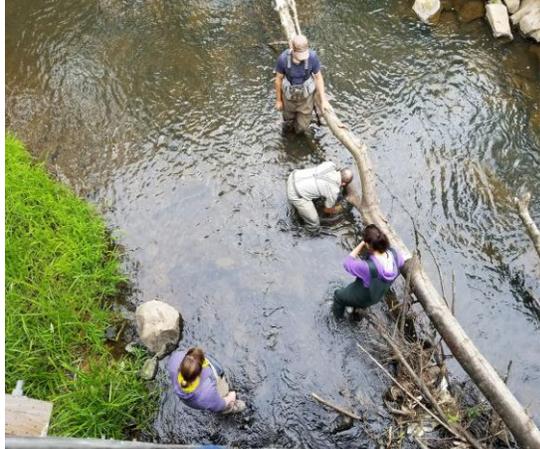
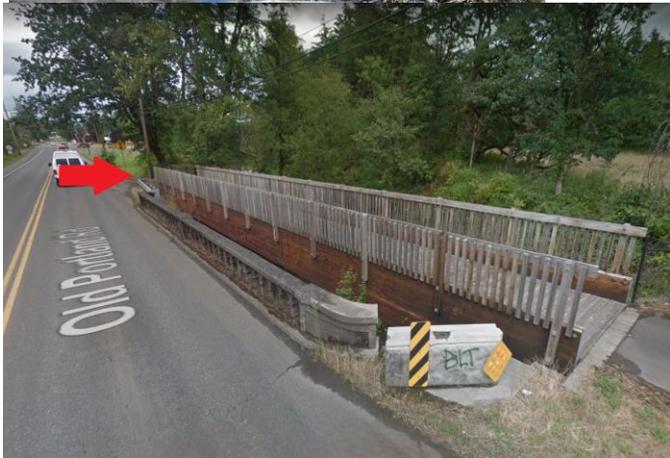
Location Image (looking down from the bridge, Matt is bending over data logger placement):

Site Code	Site Name	Description	GPS Coordinates	Logger Serial Number	Installed Date/Time	Installed Temp °C
LM	Lower Milton	Data: Bacteria, Temp/WL, Turbidity Located in McCormick Park on the downstream side of the Old Portland Road Bridge - under woody debris	Lat: 45.850289	20112656	6/28/2017 11:28	16.3
			Long: -122.816039

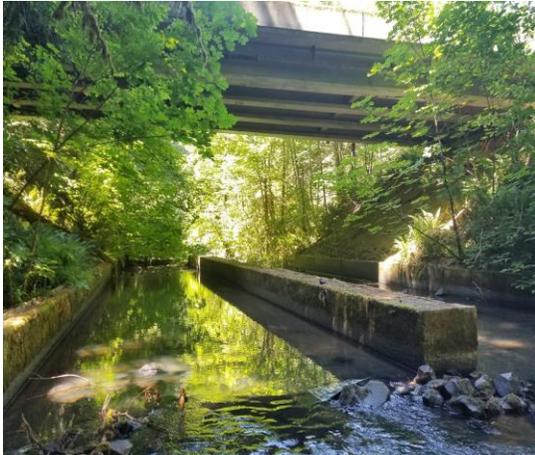
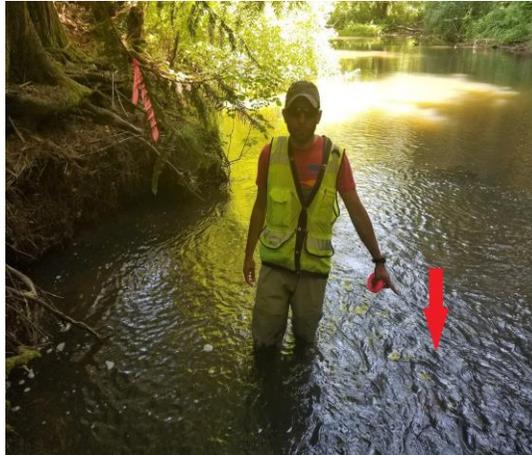
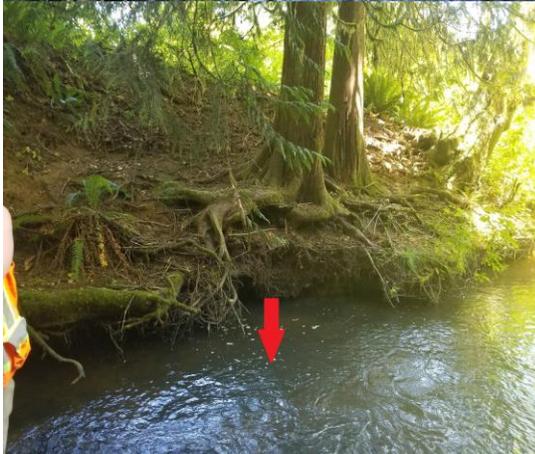
Location images: Downstream of bridge (a bit) near the north stream bank under flagged cedar tree in pool

Site Code	Site Name	Description	GPS Coordinates	Logger Serial Number	Installed Date/Time	Installed Temp °C
UM	Upper Milton	Data: Temp/WL, Turbidity Downstream side of W. Kappler Rd bridge (very steep), data logger located downstream of bridge under flagged cedar tree.	Lat: 45.864193 Long: -122.886893	20112650	6/29/2017 12:58	15.4

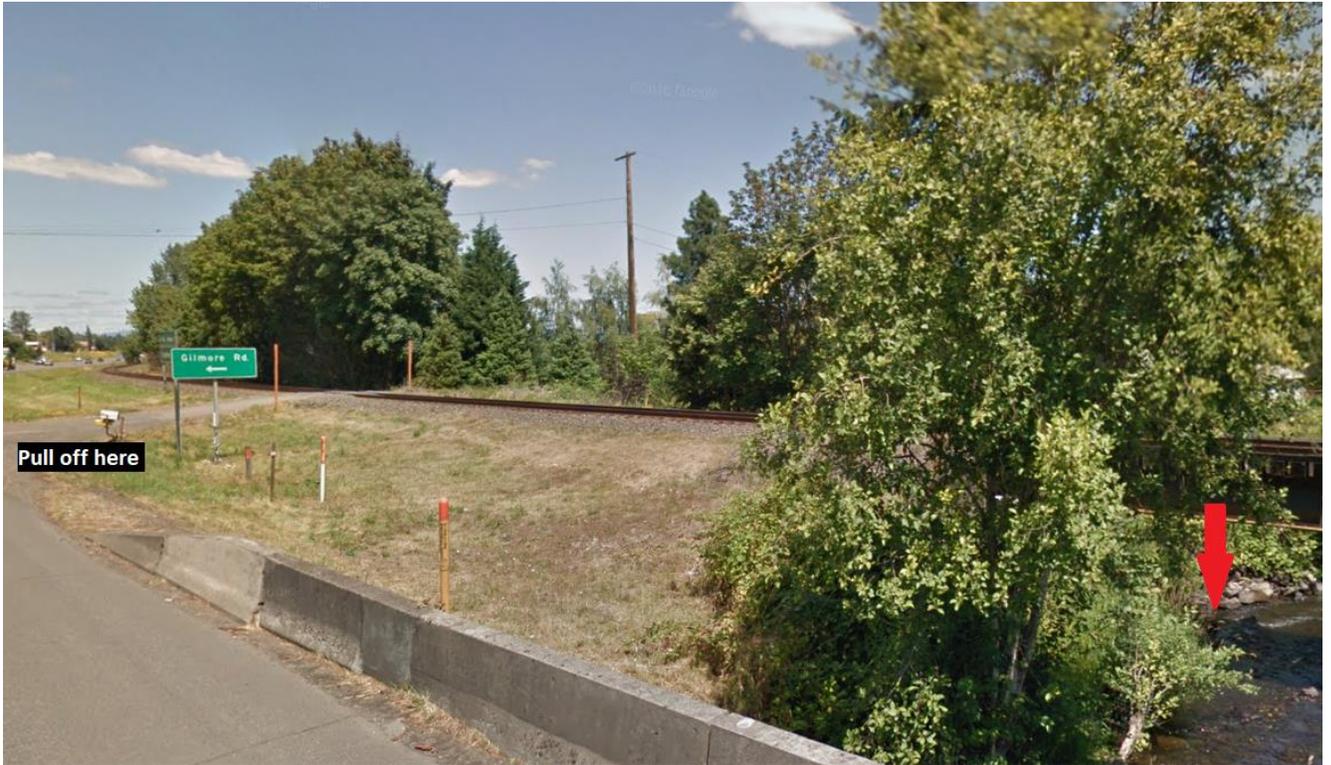
Location images: Pull off HWY 30 just north of bridge along Rosewood lane.

Scappoose Bay Watershed: North Scappoose Creek						
Site Code	Site Name	Description	GPS Coordinates	Logger Serial Number	Installed Date/Time	Installed Temp °C
LNS	Lower North Scappoose	Data: Bacteria, Temp/WL, Turbidity Pull off HWY 30 just north of bridge along Rosewood lane. Enter stream on the north bank at the railroad bridge (large patch of reed canarygrass) crossing. Data logger tided to old piling (flagged) on north bank of stream under railroad bridge.	Lat: 45.771786	20112652	6/29/2017 14:19	17.2

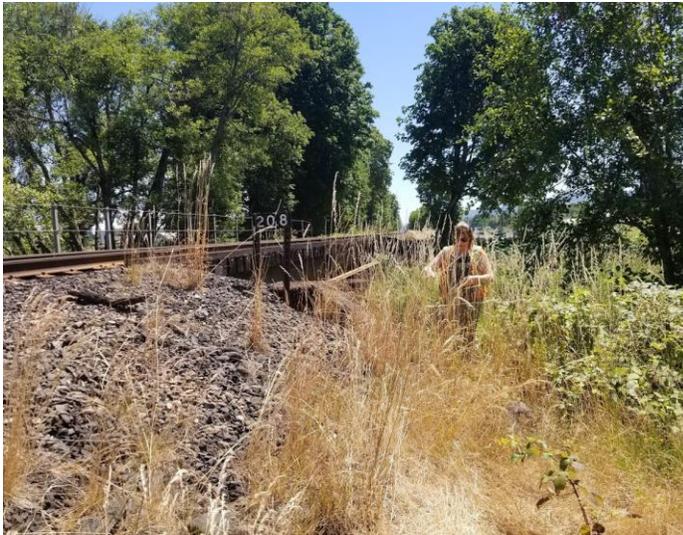
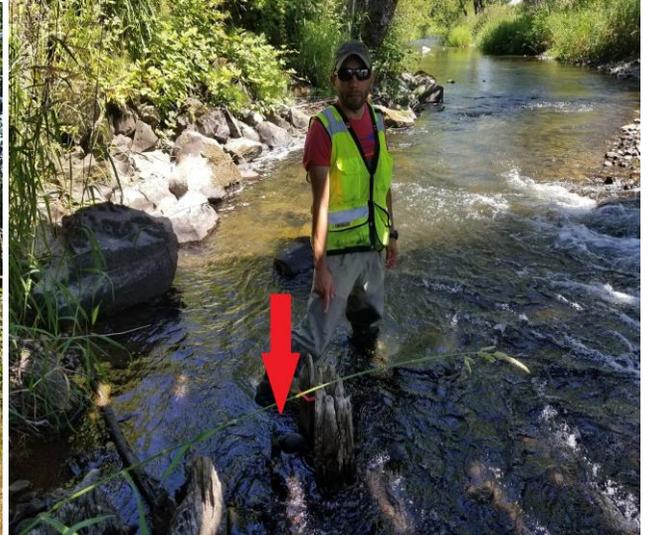
Enter stream on the north bank at the railroad bridge (large patch of reed canarygrass) crossing. Data logger tided to old piling on north bank of stream under railroad bridge.

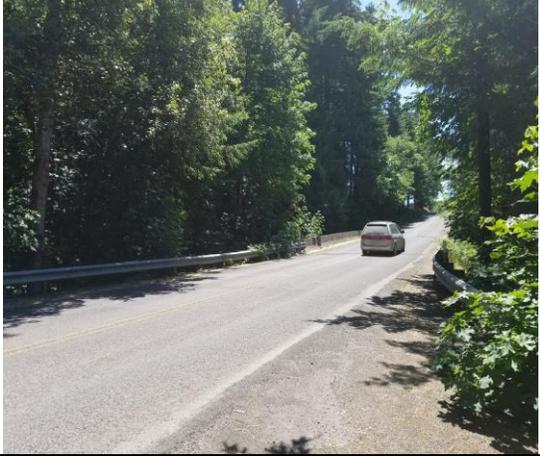
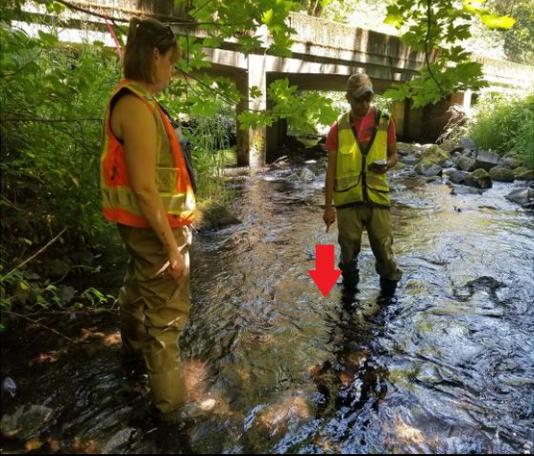
Location images: Descend on the upstream side of the bridge on the North bank. Data logger placed on North bank under maple tree (flagged).

Site Code	Site Name	Description	GPS Coordinates	Logger Serial Number	Installed Date/Time	Installed Temp °C
UNS	Upper North Scappoose	Data: Temp/WL, Turbidity Pull off close to the bridge crossing river near 30161 Scappoose Vernonia Hwy. Descend on the upstream side of the bridge on the North bank. Data logger placed on North bank under maple tree (flagged).	Lat: 45.823753 Long: -122.946923	20112655	6/29/2017 13:37	14.4

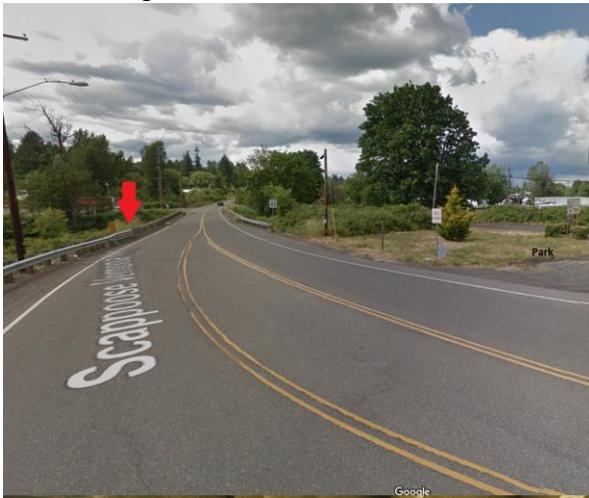
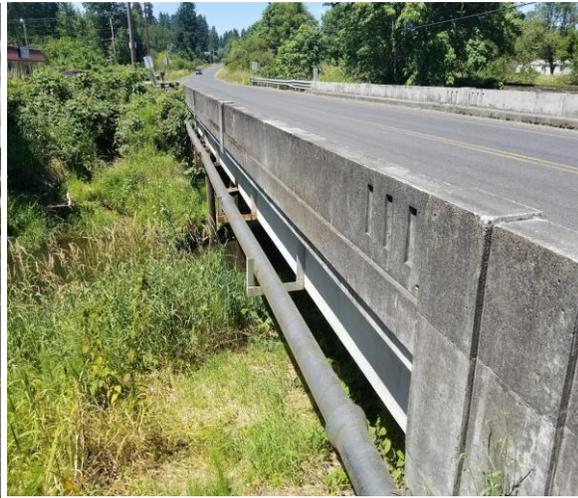
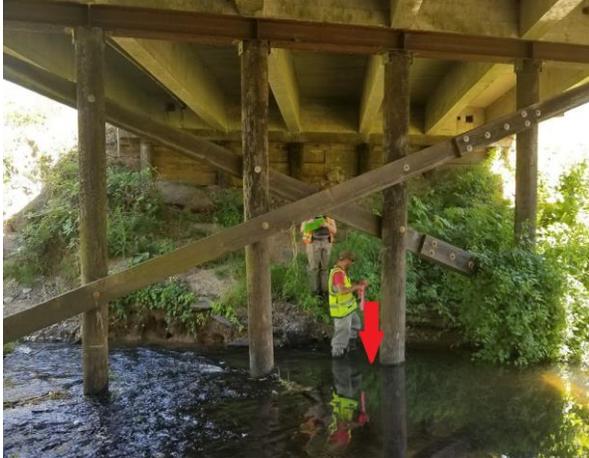
Location images:

Site Code	Site Name	Description	GPS Coordinates	Logger Serial Number	Installed Date/Time	Installed Temp °C
LSS	Lower South Scappoose	Data: Bacteria, Temp/WL, Turbidity Park at the CZ trail area just off HWY 30, then decent on the south side of the bridge on the upstream side. Data logger tied to piling under bridge on south bank. Piling flagged.	Lat: 45.762739 Long: -122.880973	20112658	6/29/2017 13:59	16.3

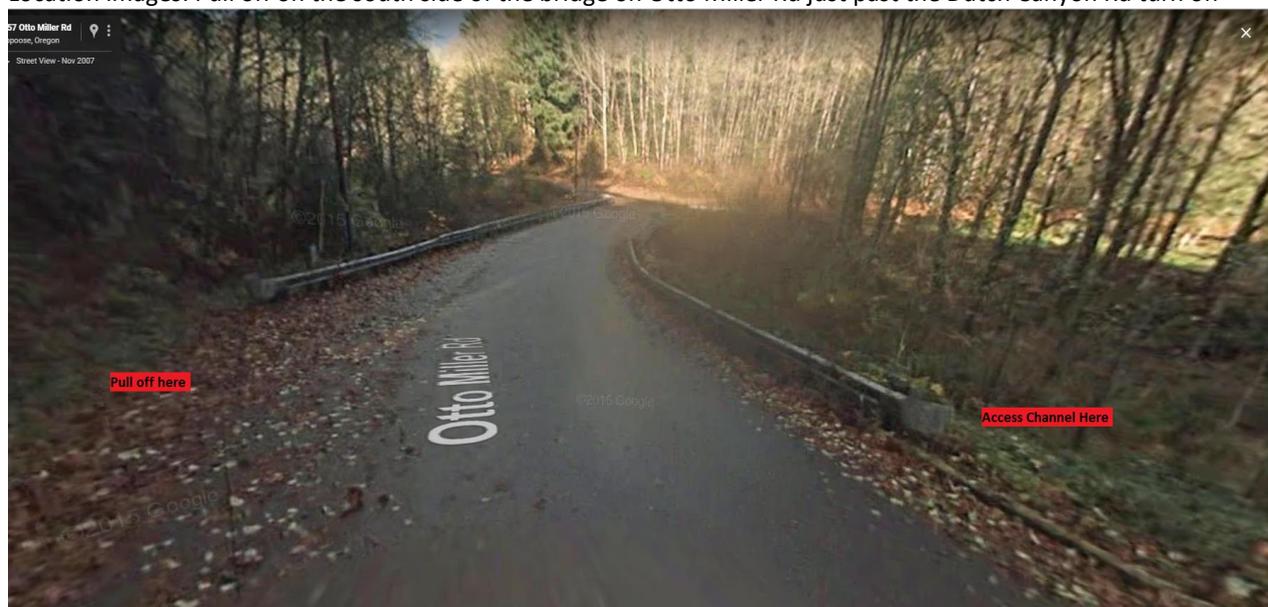
Location images: Pull off on the south side of the bridge on Otto Miller Rd just past the Dutch Canyon Rd turn off

Site Code	Site Name	Description	GPS Coordinates	Logger Serial Number	Installed Date/Time	Installed Temp °C
USS	Upper South Scappoose	Data: Temp/WL, Turbidity Pull off on the south side of the bridge on Otto Miller Rd just past the Dutch Canyon Rd turn off (see image). Data logger located downstream of bridge under an alder tree (flagged).	Lat: 45.744219 Long: -122.961964	20112664	6/29/2017 14:44	13.7

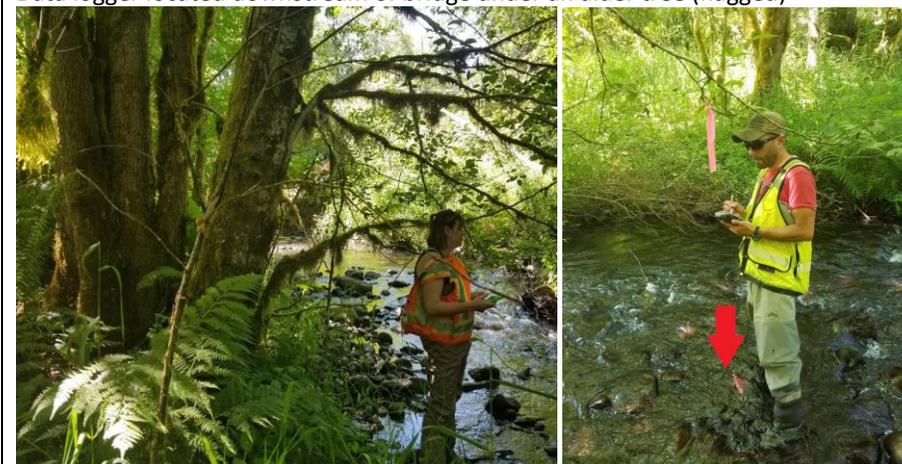
Data logger located downstream of bridge under an alder tree (flagged)
